Environmental Site Assessment

WELLINGTON SOLAR FARM

NOVEMBER 2017

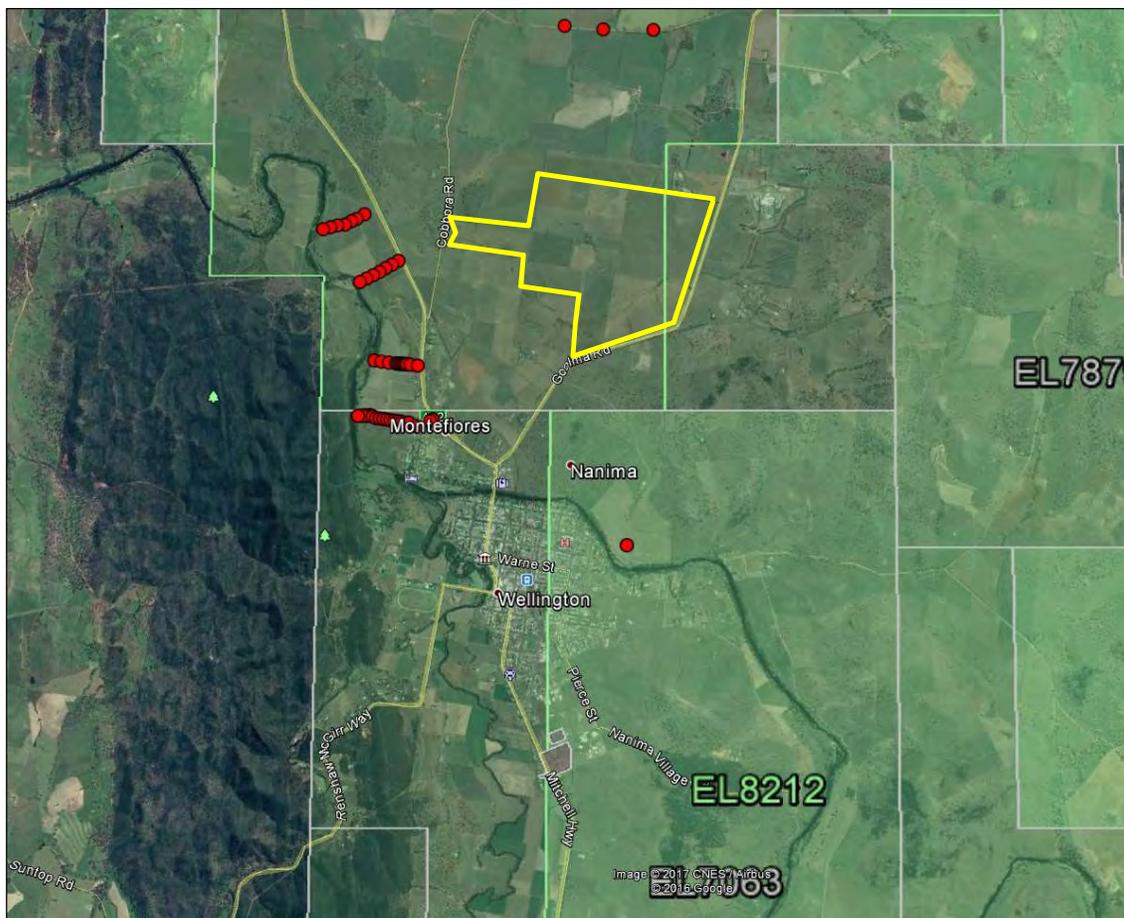
Drill holes for metallic minerals (DPI n.d.)	Wellington (suburb)	See Figure 3-1 below – red dots indicate all drill holes. The majority are for the purpose of metallic minerals.

Figure 3-1 Current mining exploration licences and drill holes (red) close to the proposal site (yellow) (Minview 2017).

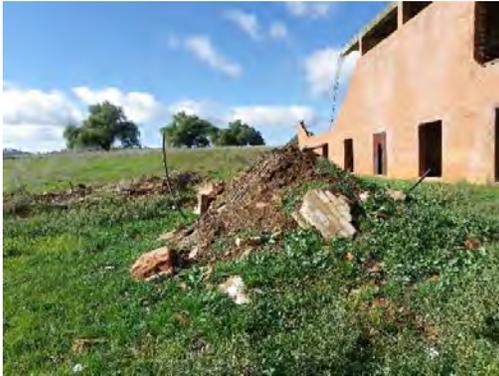
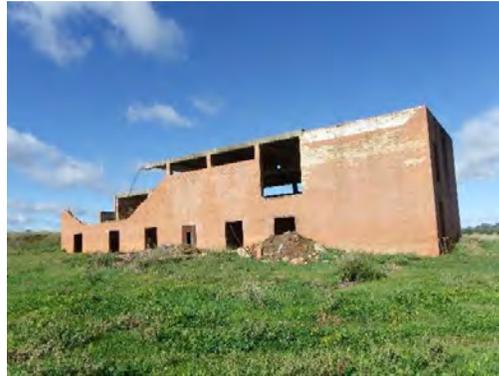
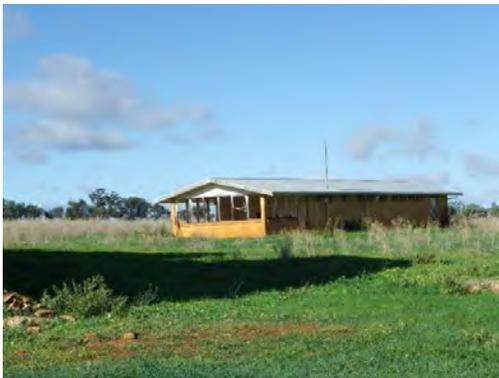
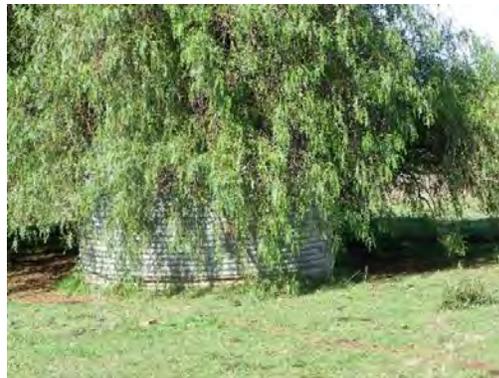
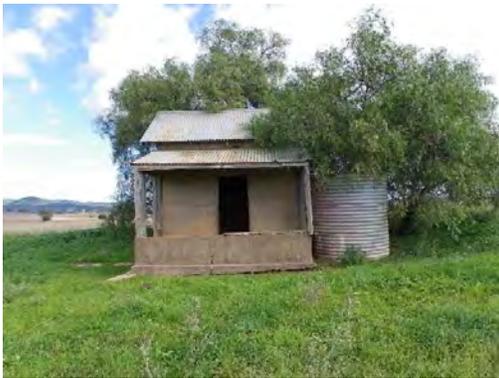
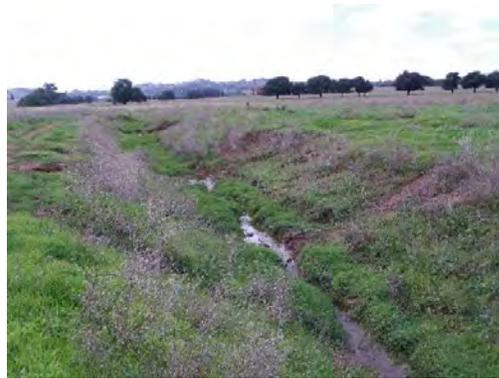
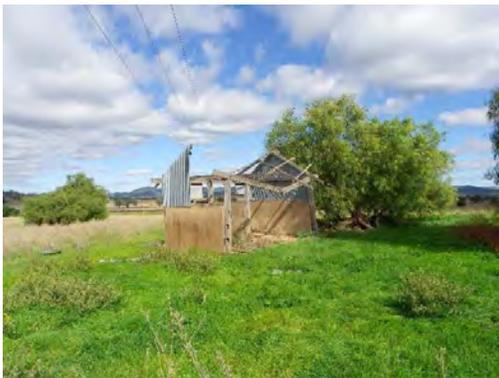
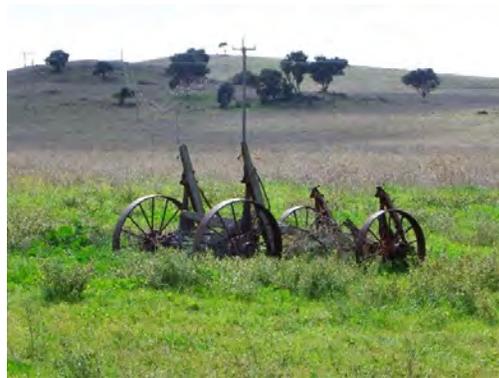
Eastern lots

The current landowner has undertaken grazing with occasional cropping for approximately 25 years. It is assumed similar land use preceded this. Dilapidated abattoir and office buildings present onsite have sometimes been used for storage of grains. These buildings were constructed by a previous landowner and were never completed or utilised as an abattoir. Drainage and septic tanks similarly were never utilised (if completed). An old single room building is also located onsite that may have been used by shearers or as a milk separating shed in the past. Above ground water tanks for bore water used for stock are also located within the proposal site.

- No mining is known to have occurred on site.
- No diesel fuel, fertilisers or herbicides are stored onsite.
- No underground storage tanks are known to occur onsite.
- No buried waste is understood to be present onsite. All waste generated are disposed of at the local tip.
- No odours or discolouration of soil or vegetation was noted during the site inspection. Additionally, no salt scalding was present.
