Document:	Geotechnical Investigation
File Location:	I:\Projects\30041768 - Wyalong SF GI\04 Technical\Geotechnical\Final Report
Project Name:	West Wyalong Solar Farm
Project Number:	30041768
Revision Number:	Rev 1

This executive summary presents the findings of the geotechnical investigation (GI) undertaken by SMEC Australia Pty Ltd (SMEC) for the West Wyalong Solar Farm (WWSF) project, on behalf of Lightsource BP. The proposed site for WWSF is located approximately 20 km North West of West Wyalong, New South Wales.

It is understood that the proposed solar facility development is a 112 Megawatt utility-scale renewable energy project, covering an area of about 285 hectares.

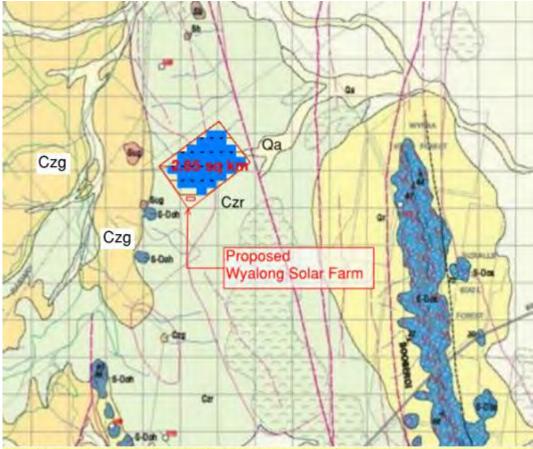
The Wyalong geological map also indicates that the areas to the east of the site comprise of Quaternary age Cainozoic Formation (Qa) that typically comprise - alluvium and west of the site comprise of Tertiary age Cainozoic Formation (Czg) that typically comprise highly weathered granite and colluvial sediments. An extract of the Geological Map of New South Wales, Wyalong (1:100,000 scale) is shown in Figure 2.

Czr: Tertiary age, Cainozoic Formation - typically comprises of silt, sand and clay with gravels.

Czg: Tertiary age, Cainozoic Formation - typically comprise highly weathered granite and colluvial sediments.

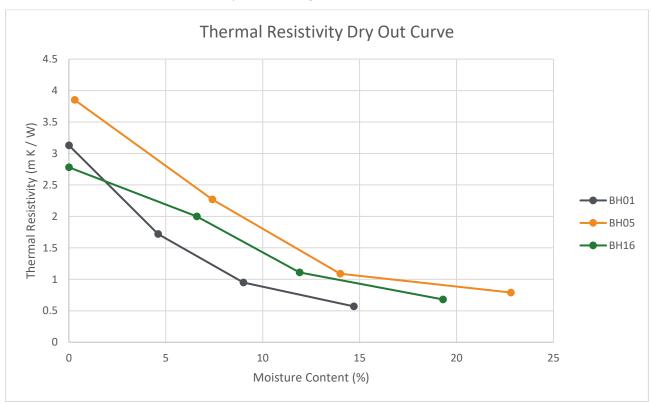
Figure 3: Thermal Resistivity Findings

The thermal resistivity of soil varies with soil type, density, structure and moisture content. Laboratory testing of three bulk samples was undertaken using the Dry Out Curve procedure which provided thermal resistivity and moisture content results that are plotted on Figure 3.

Observations from the laboratory test results include:

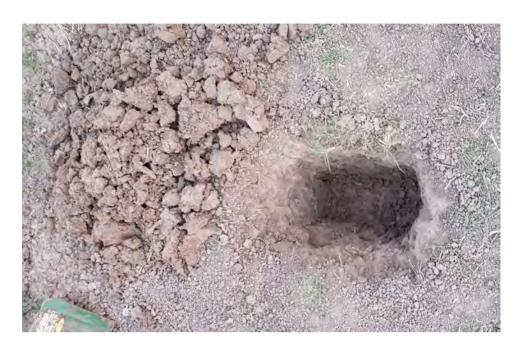
Photo 1: Shallow pit excavated at BH03 for sample collection

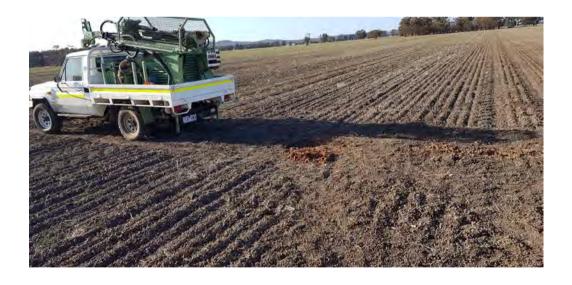
Photo 2: Terrain near BH05

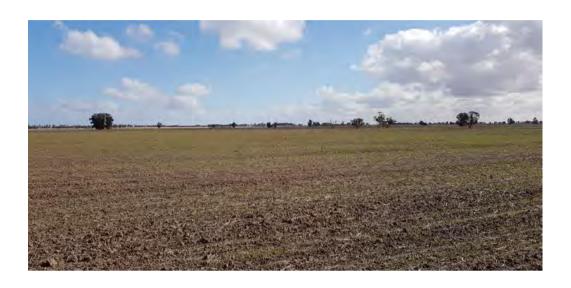
Photo 3: View of the relatively flat terrain near BH09

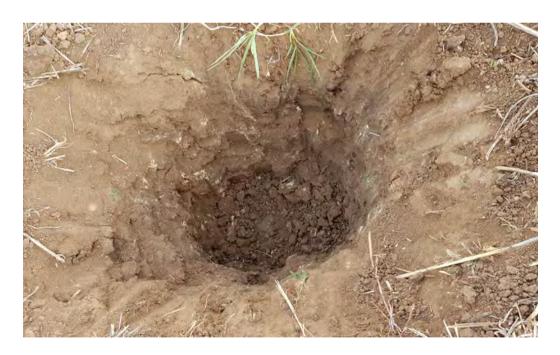
Photo 4 : Shallow pit excavated at BH10 for sample collection

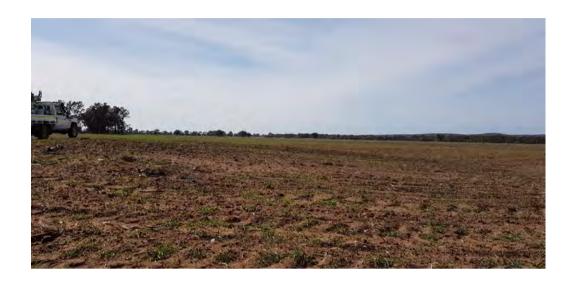
Photo 5: Slightly undulating terrain at BH10

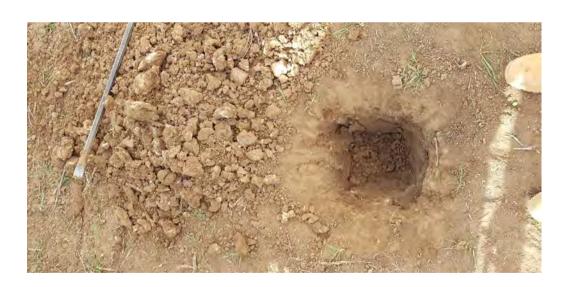
Photo 6: Shallow pit excavated at BH12 for sample collection

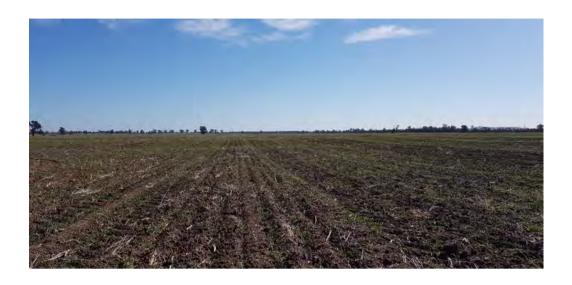
Photo 7: View of the site from BH14, showing near surface disturbance from ploughing

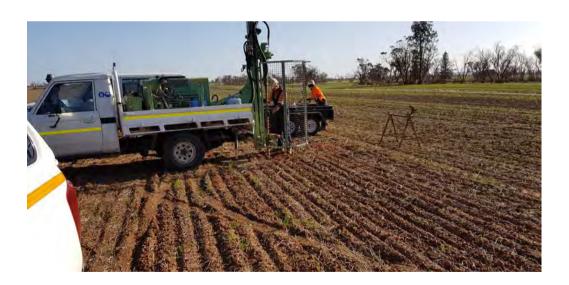
Photo 8 : Drill rig setup at BH19

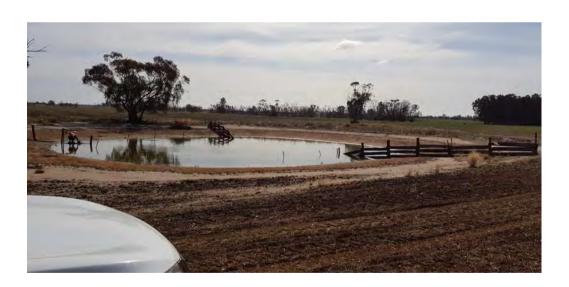
Photo 12: View of the farm dam in the centre of the site, north-east of BH21

From the site walkover, the site was observed to be generally flat with dry wheat crops (vegetation) on the surface. Some undulations were observed towards the southern and south-eastern sides of the site (noted around boreholes BH29, BH15, BH21). There were large trees intermittently spread on site; most trees near boreholes BH26 and BH21. There was an abandoned structure near borehole BH26 and a small dam near borehole BH21. Site photographs are presented in Appendix B.

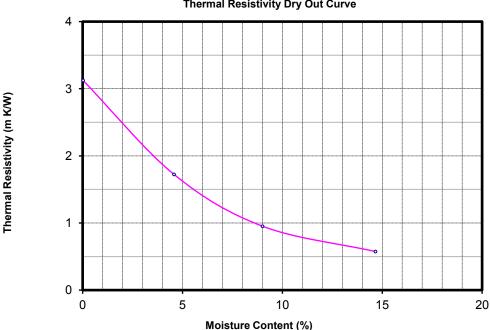
Thermal Resistivity Dry Out Curve

Resistivity Meter: TC1396 Needle ID.: 0239 Needle Resistance: 82.93 Ohm/m

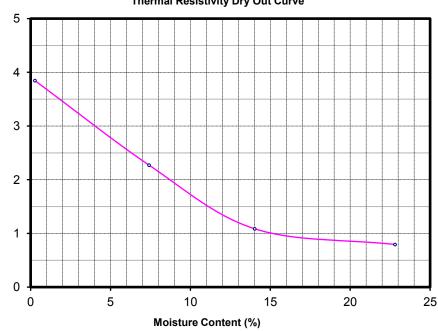
Thermal Resistivity Dry Out Curve

Resistivity Meter: TC1396 Needle ID.: 0239 Needle Resistance: 82.93 Ohm/m

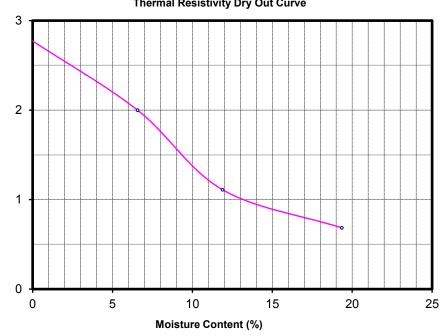
Thermal Resistivity Dry Out Curve

Resistivity Meter: TC1396 Needle ID.: 0239 Needle Resistance: 82.93 Ohm/m

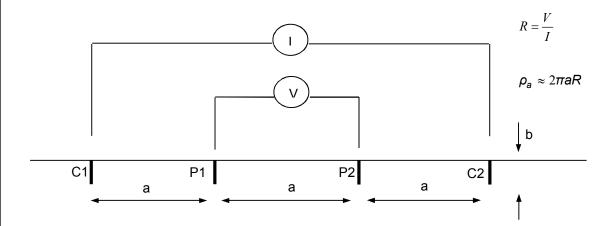
Measured Data

a [m]	b [m]	Ω	$\rho_a \left[\Omega.m\right]$
0.5	0.1	7.89	24.79
1	0.1	1.79	11.25
2	0.1	0.44	5.53
4	0.1	0.18	4.52
8	0.1	0.10	5.03
16	0.1	0.04	4.02
32	0.1	0.03	6.03
50	0.1	0.02	6.28
80	0.1	0.02	10.05

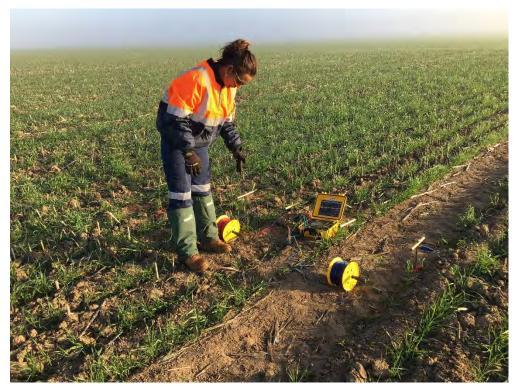
Figure 3: Testing process- AEMC 6472 Ground Tester

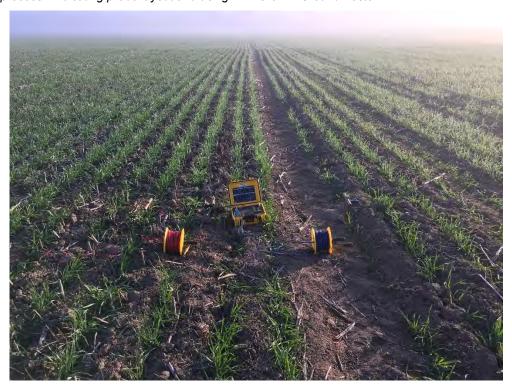
Figure 4: Testing process - indicating probe layout and using AEMC 6472 Ground Tester
